Gem-2® Flushometer

TROUBLESHOOTING GUIDE

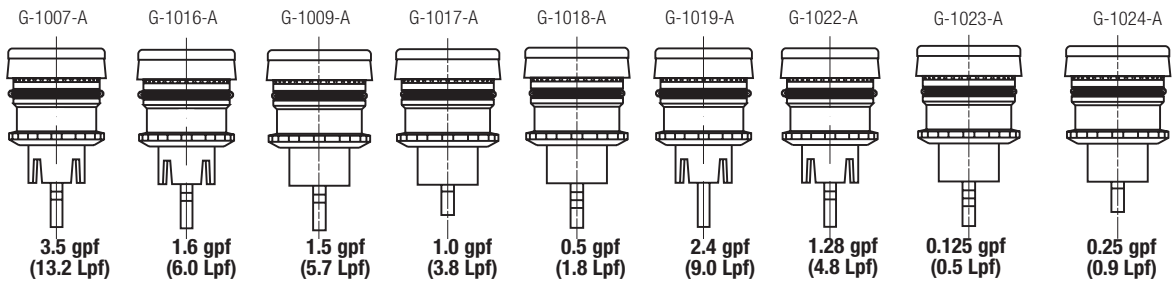
Gem•2 Pistons can be identified by the color, shape and marking of the above components.

ITEM 3. PISTON KITS

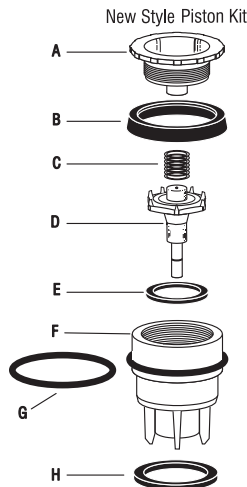
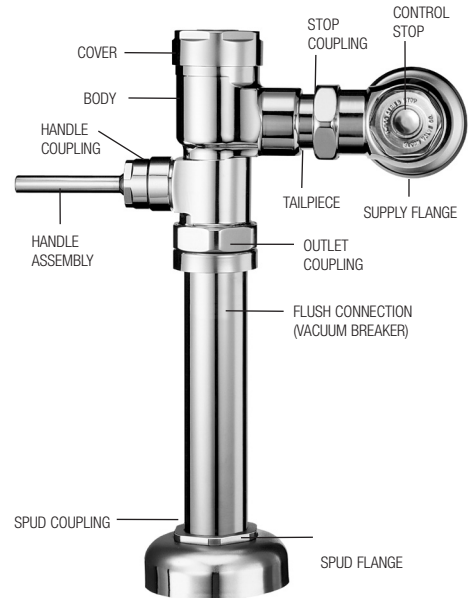
ITEM 3. PISTON COMPONENTS

Item	Code No.	Part No.	Description
A.	***	***	Piston Cover
B.	5307106	G-78	Molded Cup – 12 per package
C.	0307130	G-102	Spring
D.	***	***	Relief Valve
E.	0307116	G-95	Relief Valve Seat
F.	***	***	Piston Body
G.	0307210	G-85	Filter O-ring
H.	5307052	G-21	Main Seat – 6 per package

Code No.	Part No.	Description
3307128	G-1011-A	Repair Kit includes Items: 2, B, C, E, G & H
